MICROBIOLOGICALLY INFLUENCED CORROSION OF COPPER ALLOYS IN SALINE WATERS  
CONTAINING SULFATE-REDUCING BACTERIA

Brenda Little, Patricia Wagner and Richard Ray

Naval Oceanographic and Atmospheric Research Laboratory (Code 333)

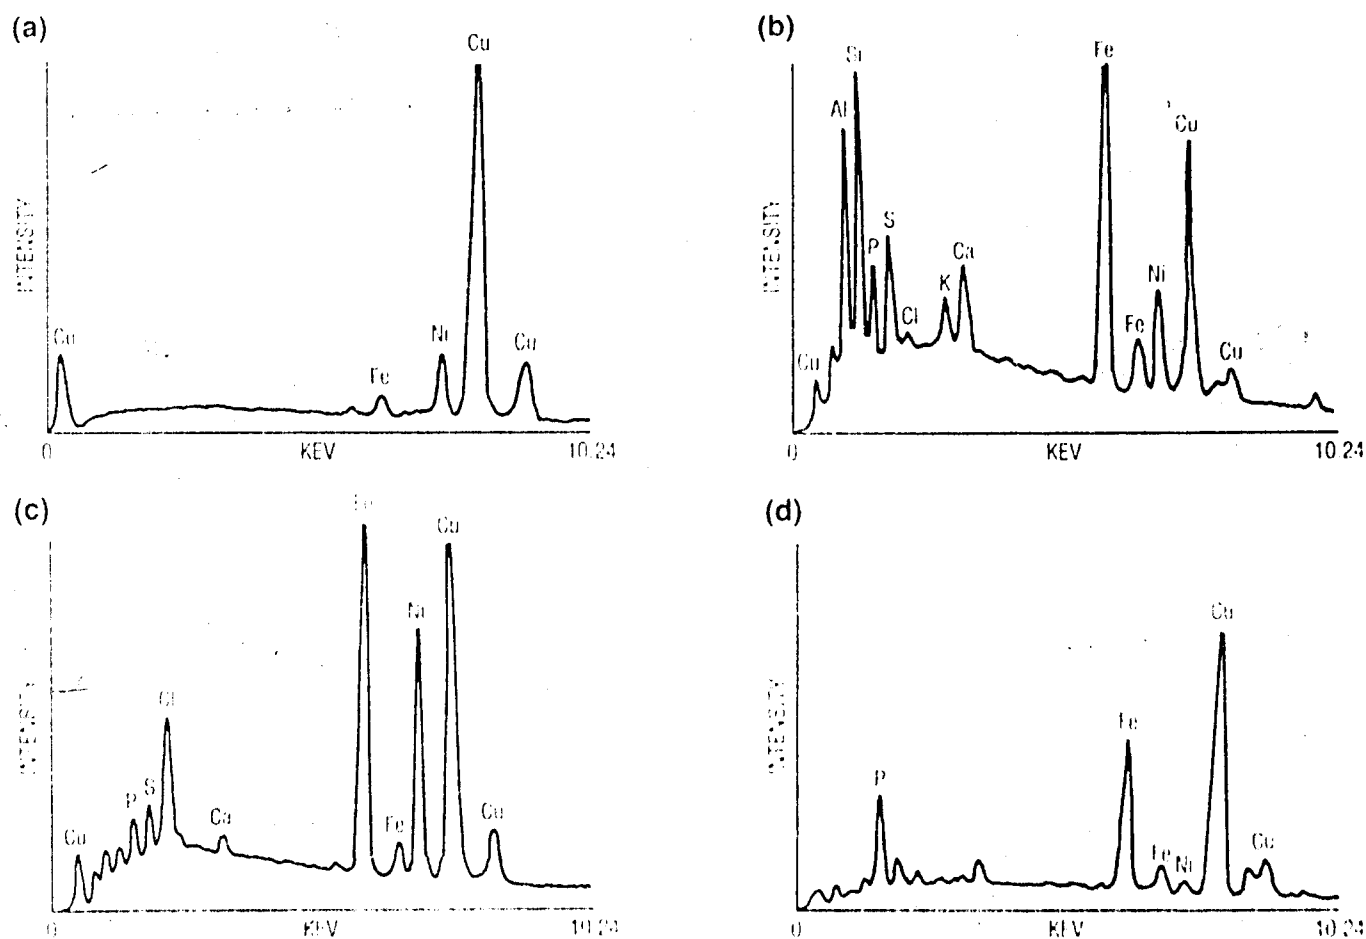
Figure 2. (a) EDS spectrum of clean CDA 706 before exposure; (b) EDS spectrum of pitted region of CDA 706 showing an accumulation of aluminum, silicon, phosphorus, sulfur, calcium and elevated amounts of iron and nickel; (c) EDS spectrum of pitted region of CDA 706 showing the accumulation of chlorine and elevated amounts of nickel and iron; (d) EDS spectrum of the spongy material beneath bacteria showing an accumulation of phosphorus, an enrichment of iron, and a depletion of nickel in the base of the pit.

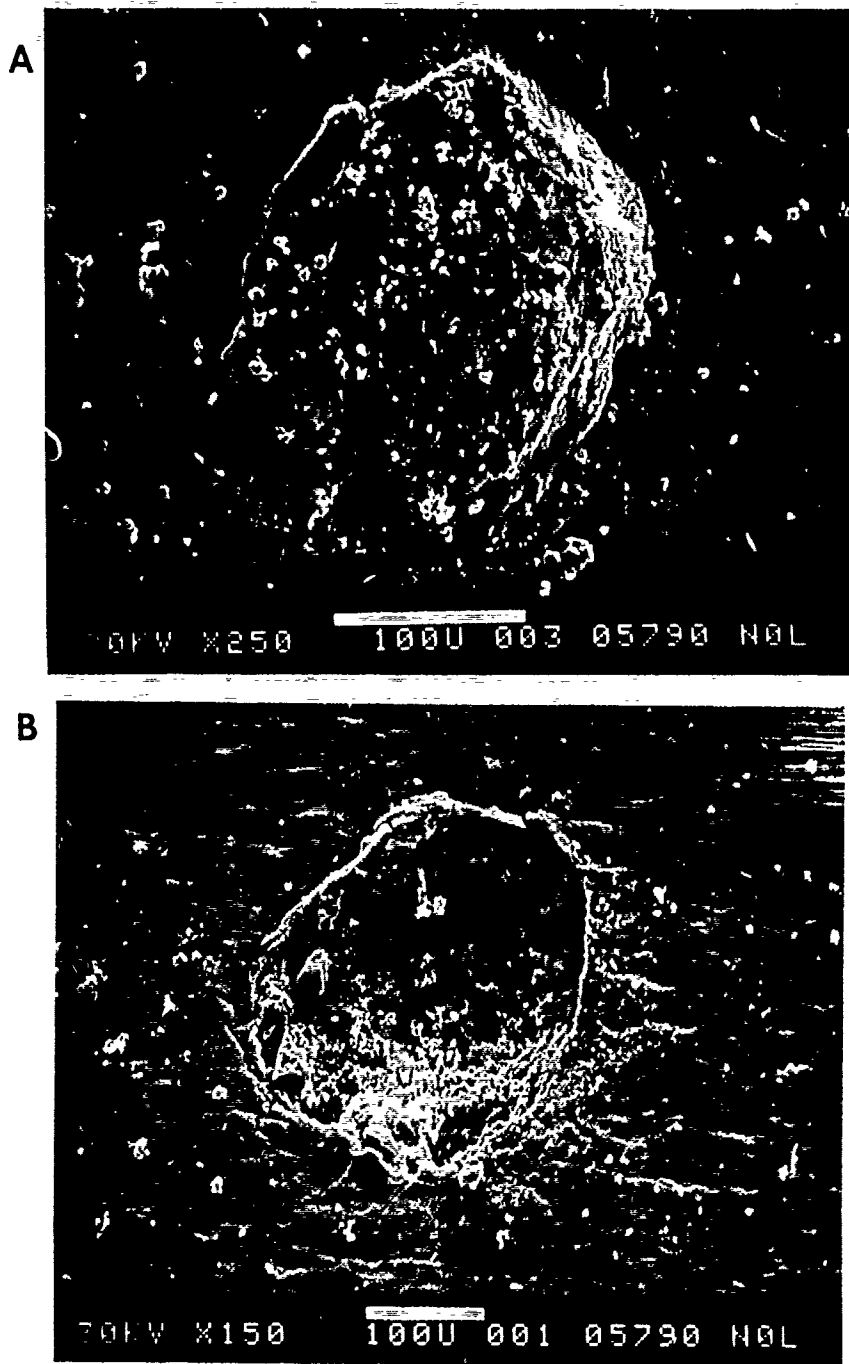
Monel 400. Visual examination of the Monel tubes indicated a multilayered scale and localized attack. The scales were characterized by surface blisters (Figure 3 a) that contained corrosion products and bacteria. The concentration of SRB within these surface deposits was typically  $1 \times 10^4 \text{ cm}^{-2}$ . Removal of the scale exposed localized, irregular-shaped pits that averaged 0.4 mm wide x 1.0 mm deep (Figure 3 b). The EDS spectrum corresponding to unexposed Monel 400 indicated the relative amounts of copper, nickel, iron and manganese in the alloy (Figure 4a). The EDS spectrum from the black layer within the pits showed an accumulation of sulfur and chlorine along with increased amounts of iron compared to the base alloy (Figure 4b). Physical removal of the biofilm from the pit exposed a copper-rich region that was depleted in nickel and iron (Figure 4c).

Corrosion of the Monel 400 tube was characterized by pit formation under blisters containing SRB. Differential aeration cells appear to have been created, with low concentration of oxygen immediately underneath the deposits creating an anaerobic environment for SRB. The surface area under the deposit becomes anodic and corrodes while the electrons that are generated react at the cathodic region of high oxygen concentration. Chlorine and sulfur had accumulated within the pit and reacted with the iron and nickel in the alloy. There was a selective leaching of nickel from the alloy leaving a spongy copper-rich material in the base of the pit.

Figure 3. (a) Blister on the surface of Monel 400 tubing after the six-month exposure to estuarine water; (b) Pit in Monel 400 tubing after the six-month exposure to estuarine water.

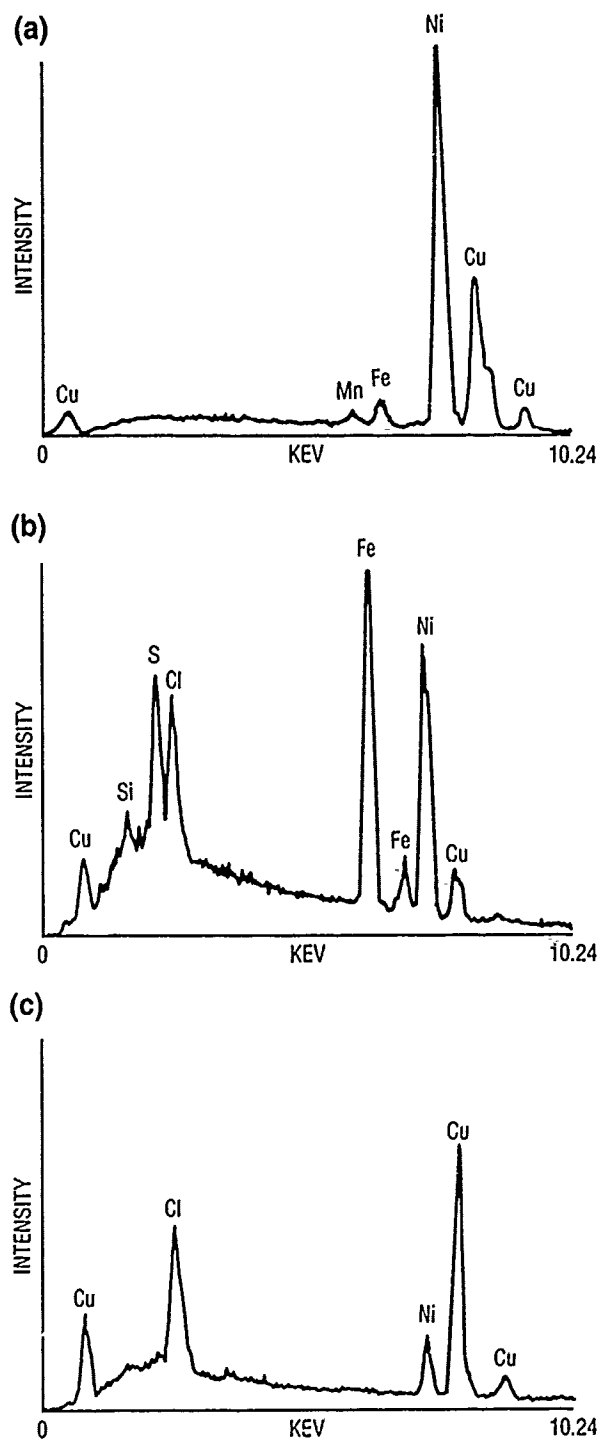
Figure 4. (a) EDS spectrum of unexposed Monel 400, (b) EDS spectrum of Monel 400 after exposure to estuarine water for six months showed an accumulation of silicon, sulfur, and chlorine with elevated concentrations of iron and nickel, (c) EDS spectrum of the residual metal in the base of the pit showing nickel depletion and copper enrichment.

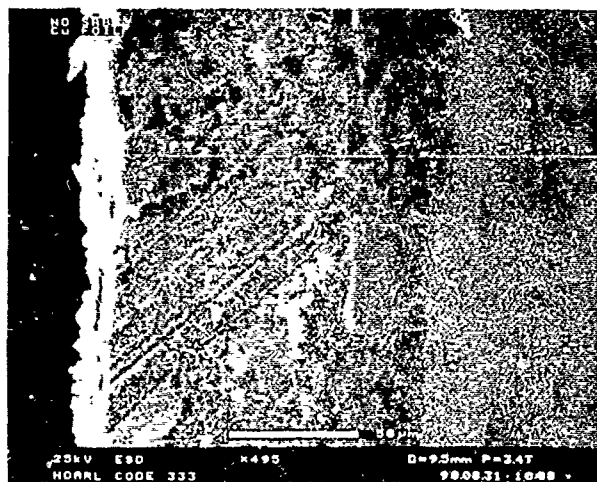
Figure 6. (a) Edge view of 99Cu foil before exposure, and (b) Edge view of 99Cu after 4-month incubation with culture III

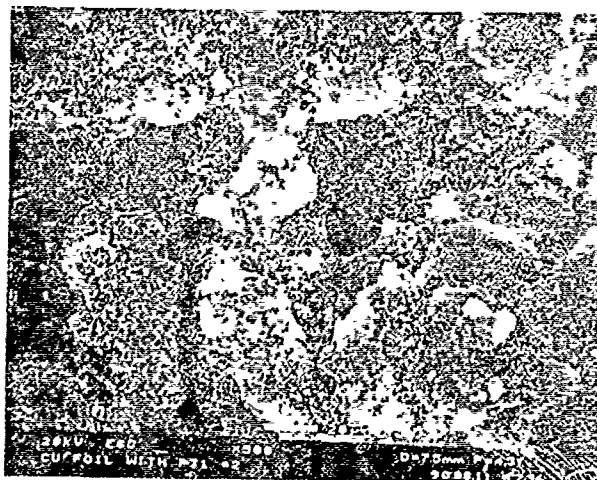
Sulfide layers on 99Cu were consistently nonadherent and in the case of culture VI most of the surface deposits sloughed into the growth medium (Figure 7). Sulfide corrosion products on copper alloys were more adherent. Sulfide layers on all brass samples were thin, tenacious and difficult to scrape from the surface. In all cases, bacteria were closely associated with the sulfur-rich deposits (Figure 8 a-d). Many of the bacteria were encrusted with deposits of copper sulfides (Figure 9). Figure 10 is an EDS spectrum collected from the surface of CDA 706 colonized by culture VII. Surface deposits were enriched in silicon, phosphorus, sulfur, manganese, iron and nickel. Table 4 is a summary of the elemental composition of 90Cu:10Ni and 70Cu:30Ni before and after colonization by cultures II and VII, respectively. In both cases the sulfide layers were enriched in iron and nickel. The biofilm on 90Cu:10Ni contained elevated amounts of manganese. The surface chemistries on brass were not evaluated because the EDS software cannot quantify zinc.

Figure 7 Surface of 99Cu after 4-month incubation with culture VI

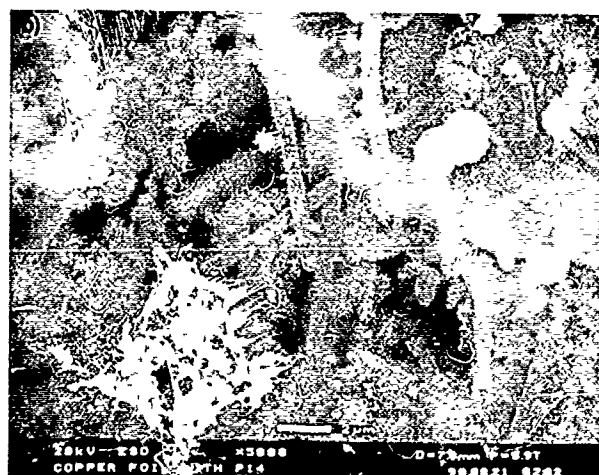
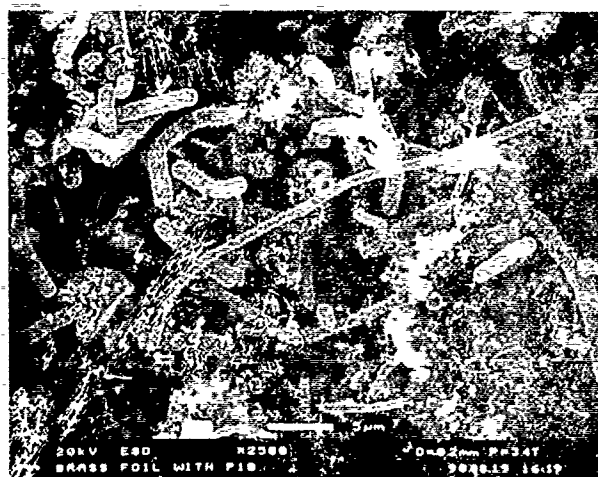
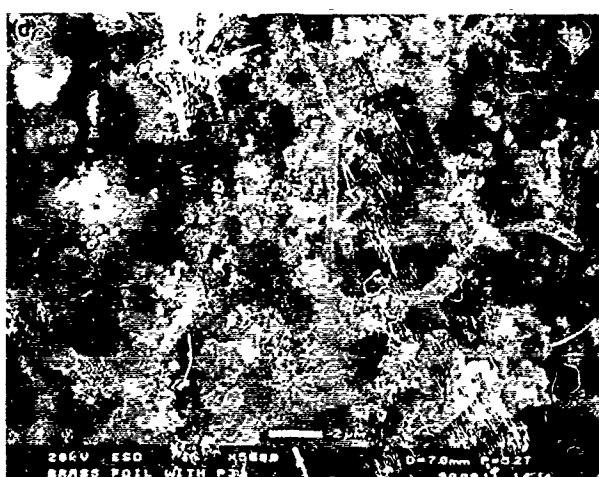
Figure 8. ESEM micrographs of biofilms: (a) Copper foil after 4-month incubation with culture II, (b) Copper foil after 4-month incubation with culture III, (c) Brass foil after 4-month incubation with culture I, and (d) Brass foil after 4-month incubation with culture V.

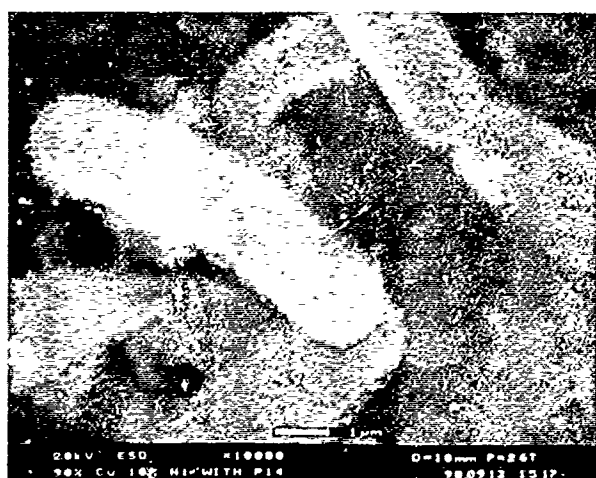
Figure 9. Sulfide deposits on cell from culture II on 90Cu, 10Ni detected by ESEM/EDS.

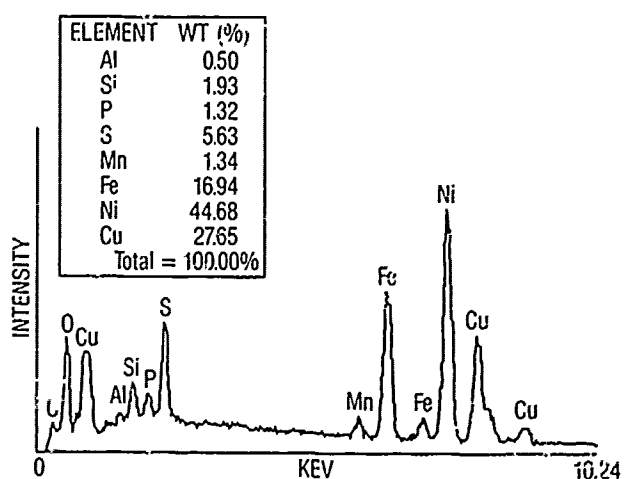
micrographs have indicated. The microbiologically produced corrosion layers were enhanced in iron and nickel relative to the base alloy suggesting selective dealloying. Manganese that accumulated within the biofilm (Figure 10) must have been bound from the culture medium. Wagner et al.<sup>42</sup> demonstrated metal binding by a marine bacterium on copper surfaces. Metal-binding is easier to detect on wet, unprepared biofilms. The role of polymer-bound metals in the corrosion of copper alloys has been addressed by Geesey.<sup>16</sup>

Figure 10. EDS spectrum collected from the surface of CDA 706 colonized by culture II.

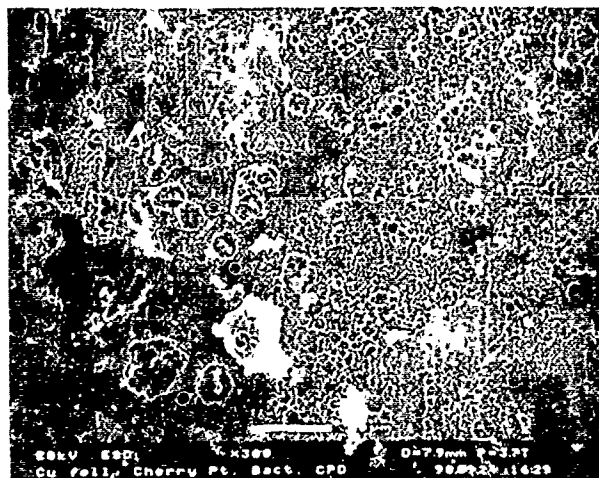
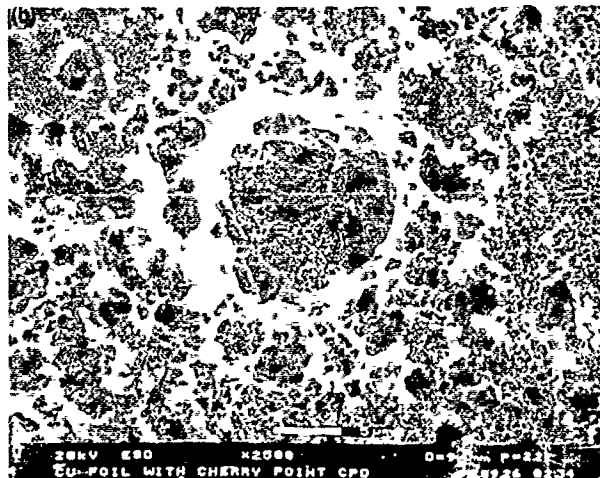
Corrosion under the uniform sulfide layers can best be described as uniform. Localized corrosion was observed under discrete deposits on the surfaces of all alloys (Figure 11).

Figure 11 (a, b) Pits on 99Cu foil after 4-month exposure to culture VII
